# WSUD Case Study: TALBOT PARK

## About Talbot Park

## Stormwater management approach

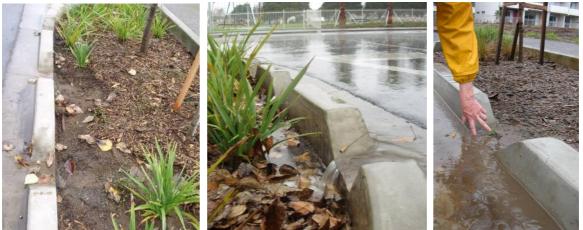
- $\circ$   $\;$  Some inlets were very close to overflows, resulting in short-circuiting of flow.
  - The design 150 mm live storage was not achieved due to a combination of low overflow grates (constructors thought they were fixing a design fault) and overfilling with media and/or mulch.

- Some inlets concentrated flow as their bases were not absolutely flat this caused scour in 8 of the 14 rain gardens in 2008.
  - Several overflow grates were 50 mm too high, so water ponded on the road.

Scouring at raingarden inlets displaced mulch and soil (left). Stormwater inflow showing concentration of water to one side of the cut, but no scouring or leaf litter displacement (centre) and stormwater prevented from entering the raingarden due to overfilling with media/mulch (right). All photos in June/July 2008.

- To reduce scour, increase kerb cuts by 250 mm minimum, install 'wings' or baffles in the drainage gutters to slow flow, and install concrete rock aprons.

- To restore design ponding depths, raise overflow grates where they are too low and excavate rain gardens where they are overfilled. Because trees had already been established for 2 years, a pragmatic decision was made to only excavate sections of raingarden without tree root mass and avoiding creating trenches that would short-circuit stormwater from inlet to overflow.

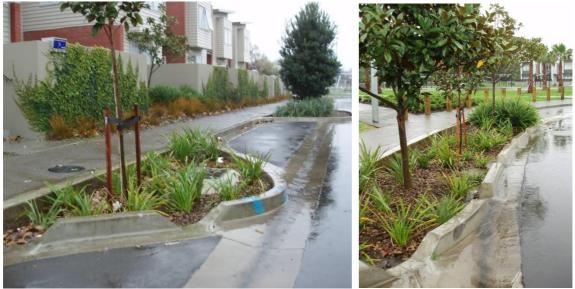
- Inlets were specified as 500 mm wide but were constructed 200 to 300 mm wide, so were prone to blockage.
  - $\circ$  Sloping parking plus gutter design exacerbated by pass flow and reduced inflow in some rain gardens, then overloaded other rain gardens.

The combination of inlet placement and gutter design means most runoff bypassed this rain garden, so overloaded the next raingarden; blue marks indicate where new kerb cuts were to be made (left) 2008. Newly renovated raingarden with c. 150 mm of media removed except around retained trees and plantings, e.g. dense flax at the far end. New inlets improve flow from the street gutter (right) 2008.

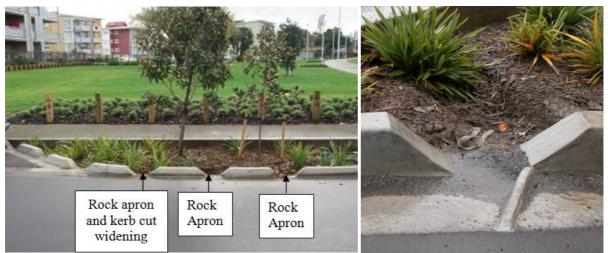
Solutions identified to scouring issues, June 2008. At this stage most groundcover plants and trees were about 18 months old, but the tree on the right is new (left). Overfilled rain garden with concrete gutter 'wing' to improve runoff entry (2008) (right).

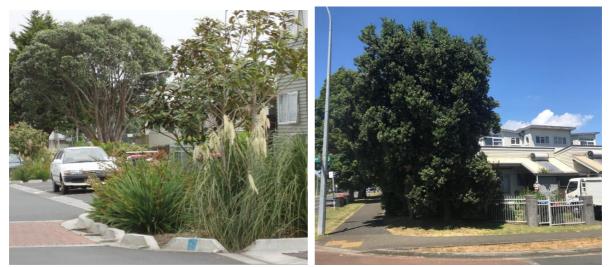
- Some individual plants were too tall and bulky for rain gardens because they grew into sight lines e.g. some flax and toetoe.

Tall toetoe were removed to ensure sight lines were maintained (2013)(left); Large trees planted in large spaces on street corners provide sense of place and welcome summer shade (right).
