Our Environment at a Glance

Environmental Science Annual Summary Report 2013/14

Our Environment at a Glance – Environmental Science Annual Summary Report 2013/14. Greater Wellington Regional Council, Publication No. GW/ESCI-G-15/28, Wellington.

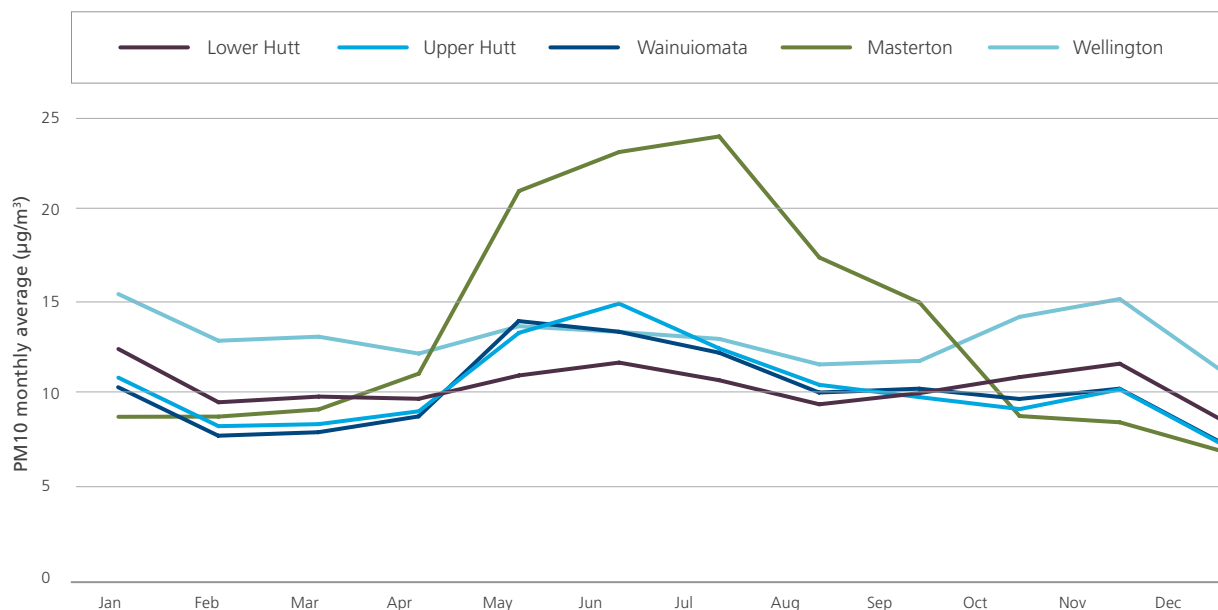
PM10 levels peak during the winter months in Masterton and to a lesser extent in Upper Hutt and Wainuiomata due to smoke from home fires. Lower Hutt and central Wellington show little seasonal differences in PM10 – air quality at these sites is more heavily influenced by traffic which is constant all year round.

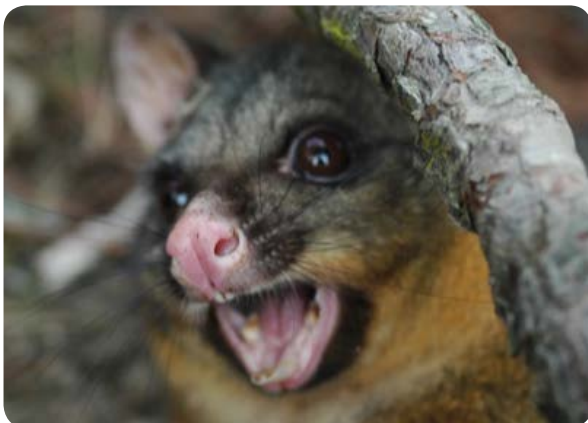
Possum and rodent levels are measured using waxtags, while pellet counts are used to assess the numbers of goats, deer, rabbits and hares

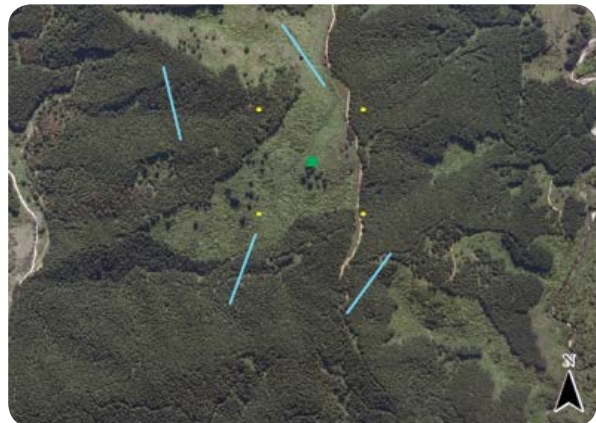
An example layout of the different monitoring activities – the green square is a vegetation plot, the yellow dots are bird monitoring sites and pest monitoring lines are shown in blue

This involves gathering data on plant and animal species from plots located on an 8km x 8km grid across the region. The Department of Conservation (DoC) is using the same system to monitor Crown land, while the Ministry for the Environment (MfE) uses the grid framework to measure vegetation for national carbon accounting purposes. There are 125 plots in the Greater Wellington region, of which 48 are being measured by DoC or MfE.

GWRC will measure birds, vegetation and pest animal species at the remaining 77 sites with data collection beginning in 2014/15.

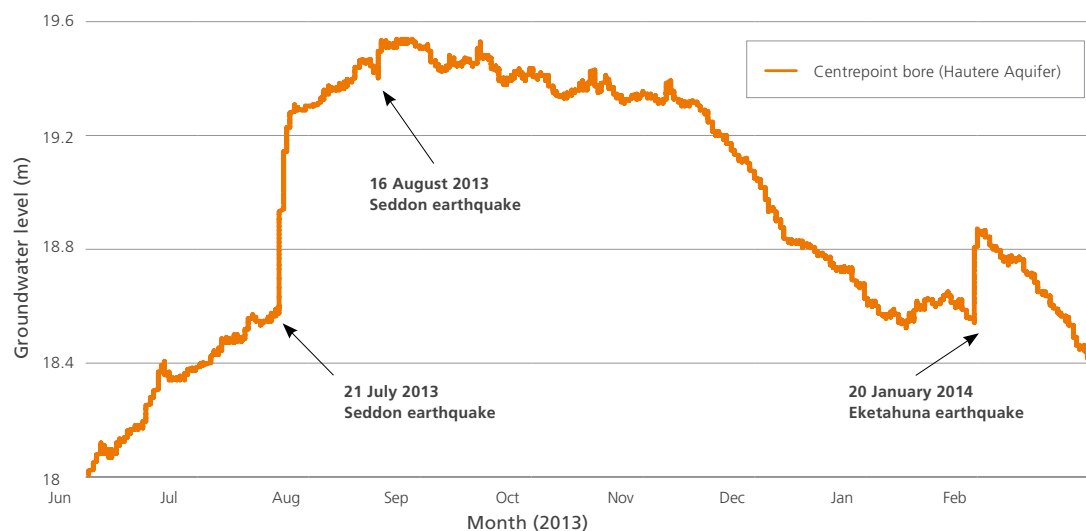
The graph below shows actual groundwater levels in the Centrepoint bore over the period of all three earthquakes. The largest response was to the initial Seddon quake where there was a sharp rise in water level of about half a metre (50cm) over 24 hours.

The Eketahuna earthquake affected groundwater levels in the Parkvale Aquifer in the Wairarapa (McNamara shallow bore) and Hautere Aquifer on the Kāpiti Coast (Centrepoint bore). Both aquifers experienced a sudden change in groundwater level, with the McNamara bore showing a decrease and the Centrepoint bore showing an increase. The McNamara bore returned to pre-earthquake levels after one day but the Centrepoint bore took about three weeks to return to normal.

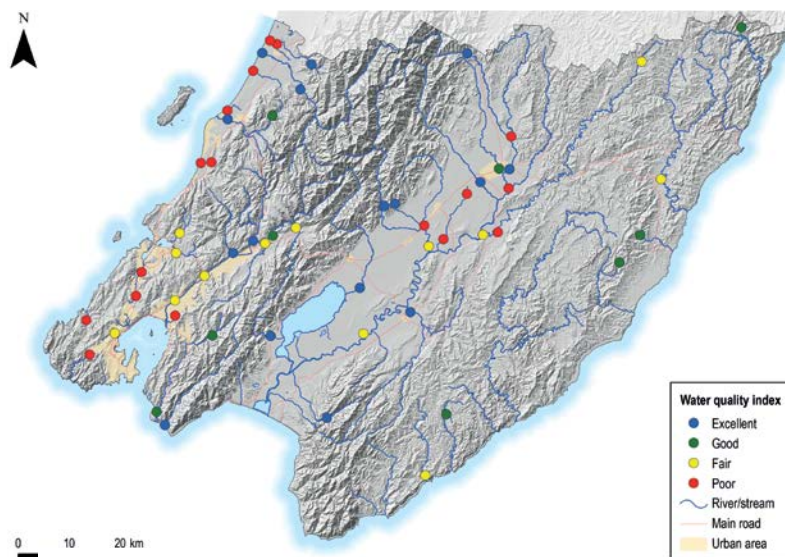
WQI ratings for river and stream sites in the Wellington region. Sixteen sites (29%) are rated as being "excellent", nine sites (16%) are rated "good", 13 sites (24%) are rated "fair" and 17 sites (31%) are rated "poor".

Using the WQI, 16 out of the 55 sites (29%) are rated as being "excellent", nine (16%) are rated "good", 13 (24%) are rated "fair" and 17 (31%) are rated "poor". This compares unfavourably to last year where 31 out of 55 sites (56%) rated as "good" or "excellent" and only 11 sites (20%) rated as "poor". However, the wetter conditions experienced during the year may have contributed to the poorer water quality observed this year.

In contrast, sites rated "poor" are typically located on small rivers or streams in areas where the predominant land cover is pasture or urban. Sites with the poorest water quality during 2013/14 were the Mangaone Stream at Sims Road Bridge (Kāpiti) and Mangapouri Stream at Bennetts Road (Kāpiti).

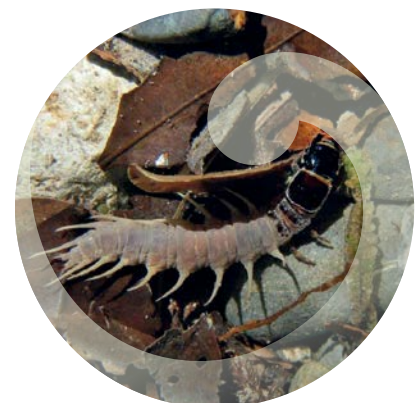
MCI quality classes for river and stream sites in the Wellington region. 17 sites (31%) are classed “excellent”, 21 sites (38%) are classed “good”, 11 sites (20%) are classed “fair” and six sites (11%) are classed “poor”.

There is a reasonable relationship between the MCI quality class and the WQI – sites with an “excellent” MCI quality class are likely to be rated as “excellent” or “good” on the WQI, and all sites with a “poor” MCI quality class were also rated “poor” on the WQI.

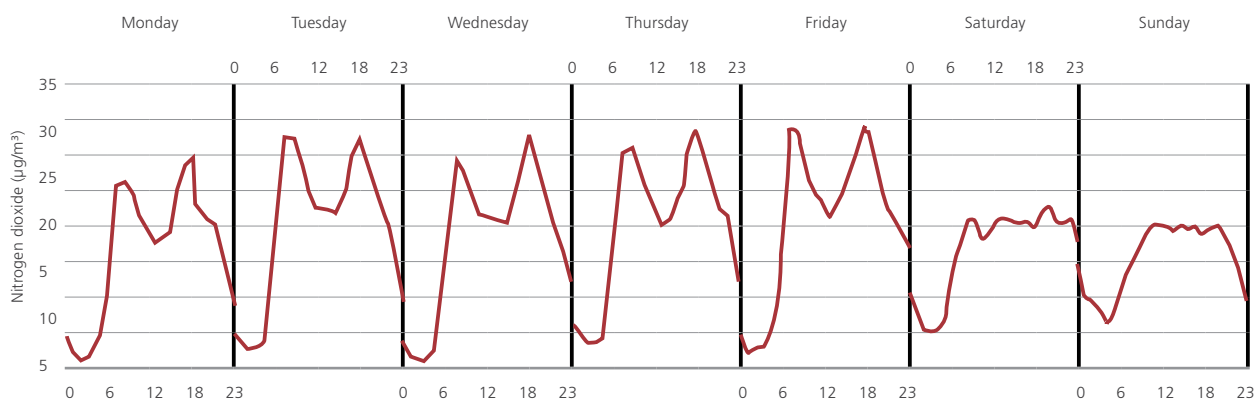
Nitrogen dioxide levels peak during morning and evening rush hour in Wellington city

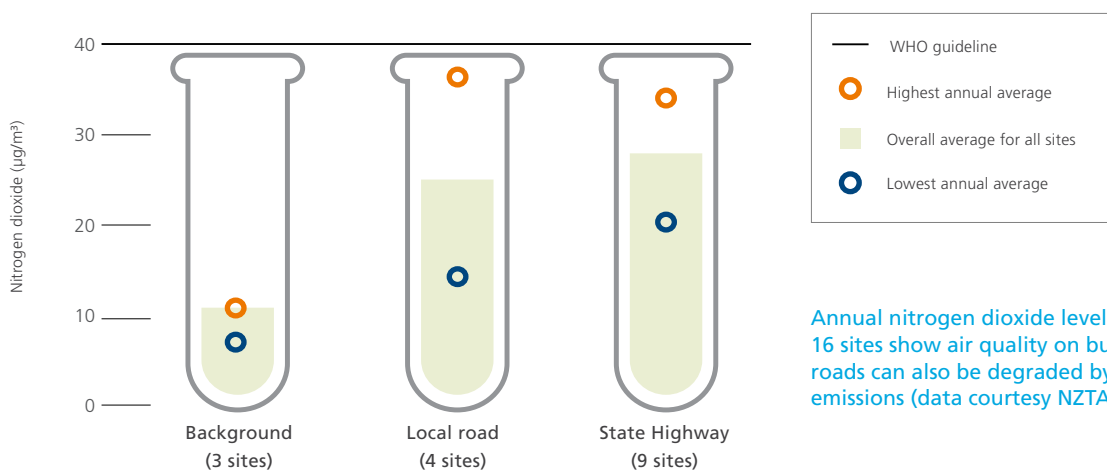
Annual nitrogen dioxide levels across 16 sites show air quality on busy local roads can also be degraded by traffic emissions (data courtesy NZTA)

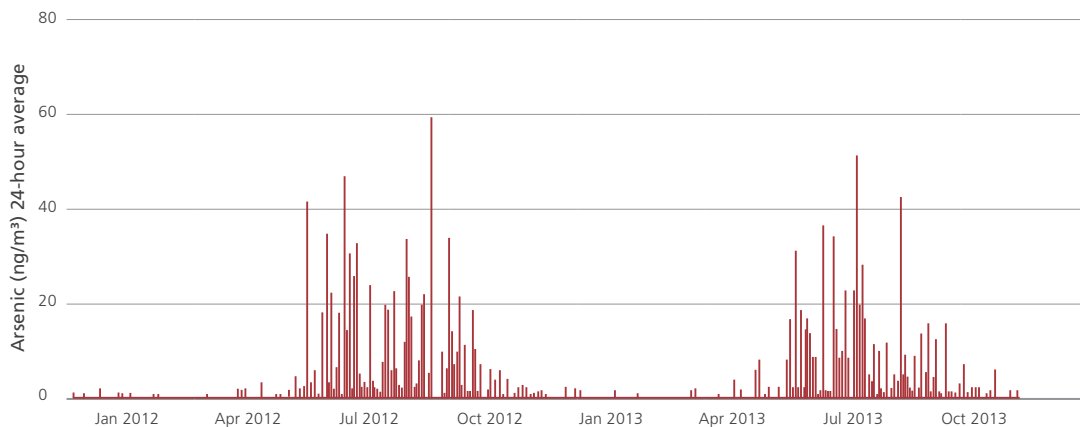
Daily arsenic levels peak in colder months (May to September) as a result of the burning of treated timber in home fires

The potential for high levels of arsenic in air arising from people burning timber offcuts treated with copper chrome arsenate (CCA) is an emerging issue of national concern as long term exposure to arsenic has been shown to increase the risk of lung cancer.

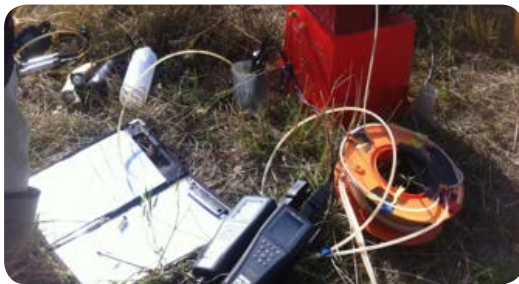
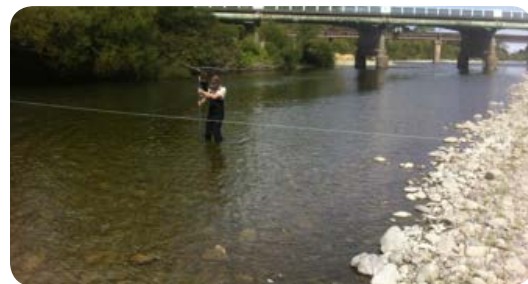
Sampling equipment (left) and measuring the flow in the Hutt River (right)

This year we collected water samples from streams, groundwater and the river in this area to better understand the nutrient inputs and their pathways. Groundwater from the Upper Hutt aquifer was identified as a key source of nitrogen (over 40 percent) in this part of the river. The source of nitrogen in the groundwater will be the focus of further investigations this coming year.

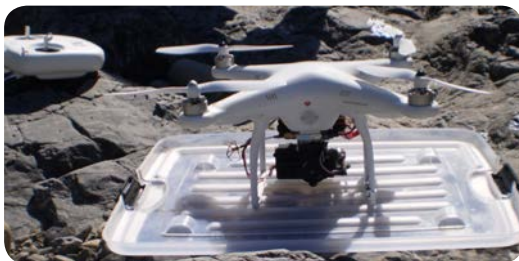
The remote-controlled helicopter which was used to trial aerial photography for monitoring coverage of toxic algae in the Hutt River

During the year we also partnered with Victoria University to trial the use of aerial photography taken by a small unmanned helicopter for monitoring the coverage of cyanobacteria in the Hutt River. In terms of proof-of-concept, the study successfully demonstrated that video sampling using an unmanned aerial vehicle can be used to assess benthic cyanobacteria abundance.

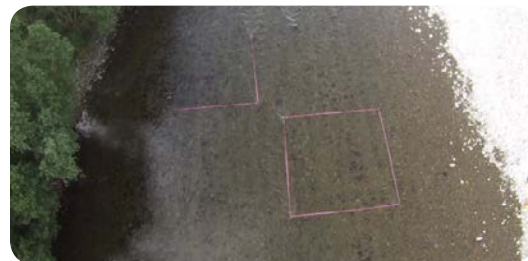
An aerial shot showing the plots used to assess the amount of toxic algae cover in the river

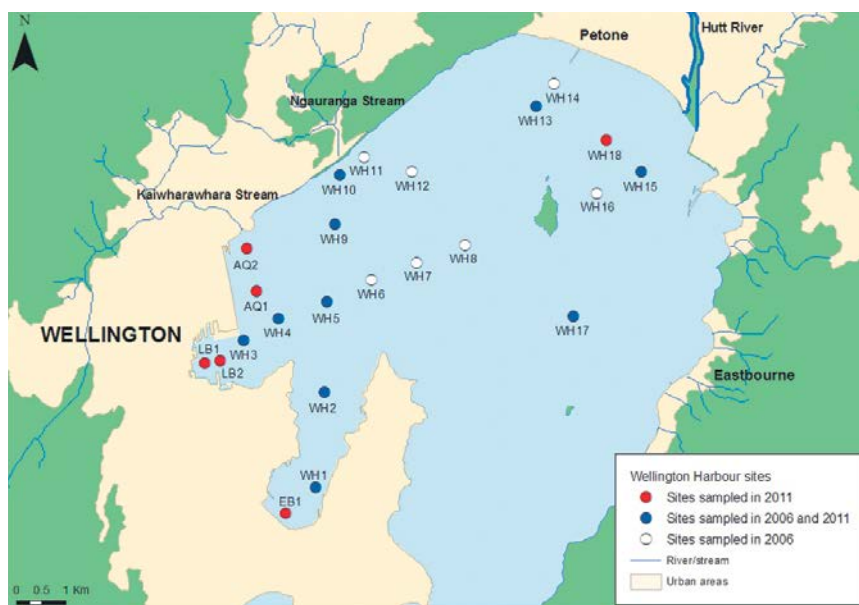
Sediment sampling sites in Wellington Harbour

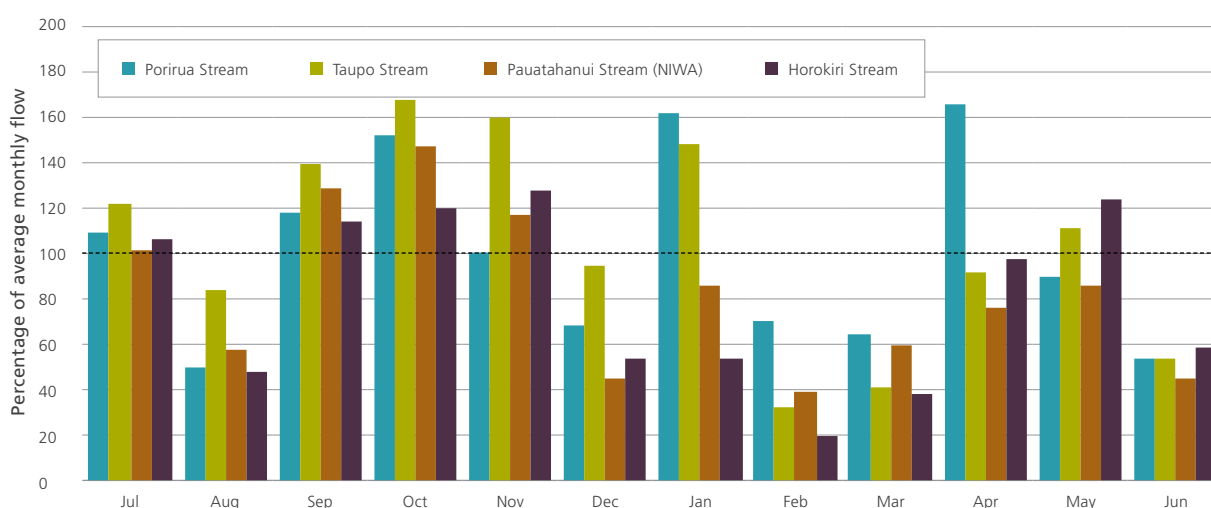
Lower than average flows in the Porirua Harbour area were experienced in December, February and March

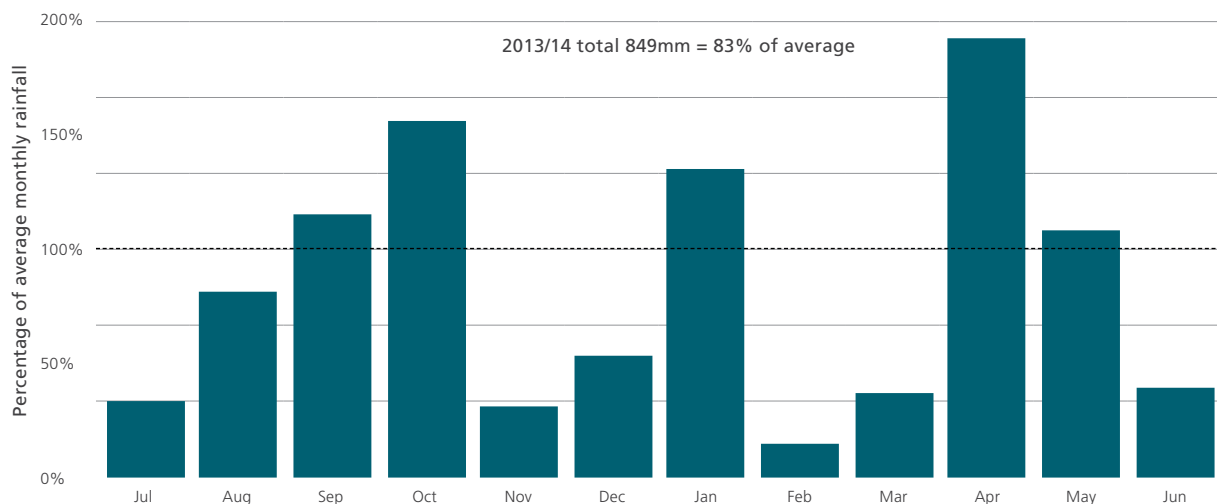
Below average rainfall was recorded at Ōtaki with February-March 2014 being particularly dry

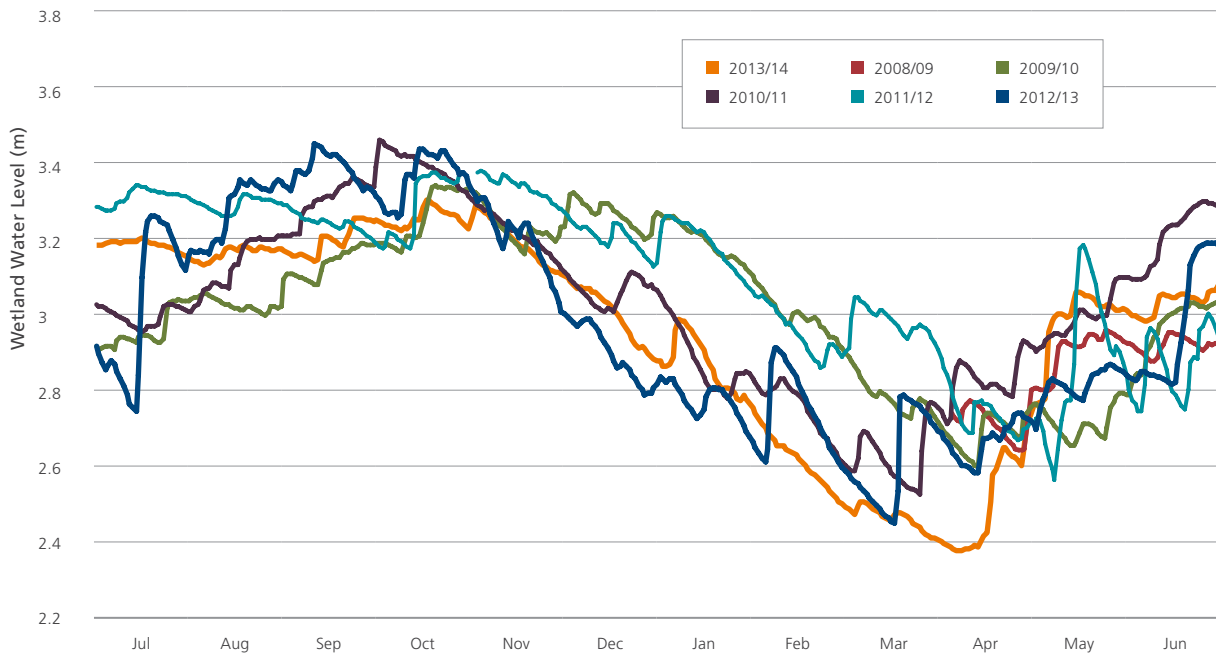
Water levels in the Te Hapua wetland complex show that water levels during late summer and early autumn were the lowest since monitoring began in 2009

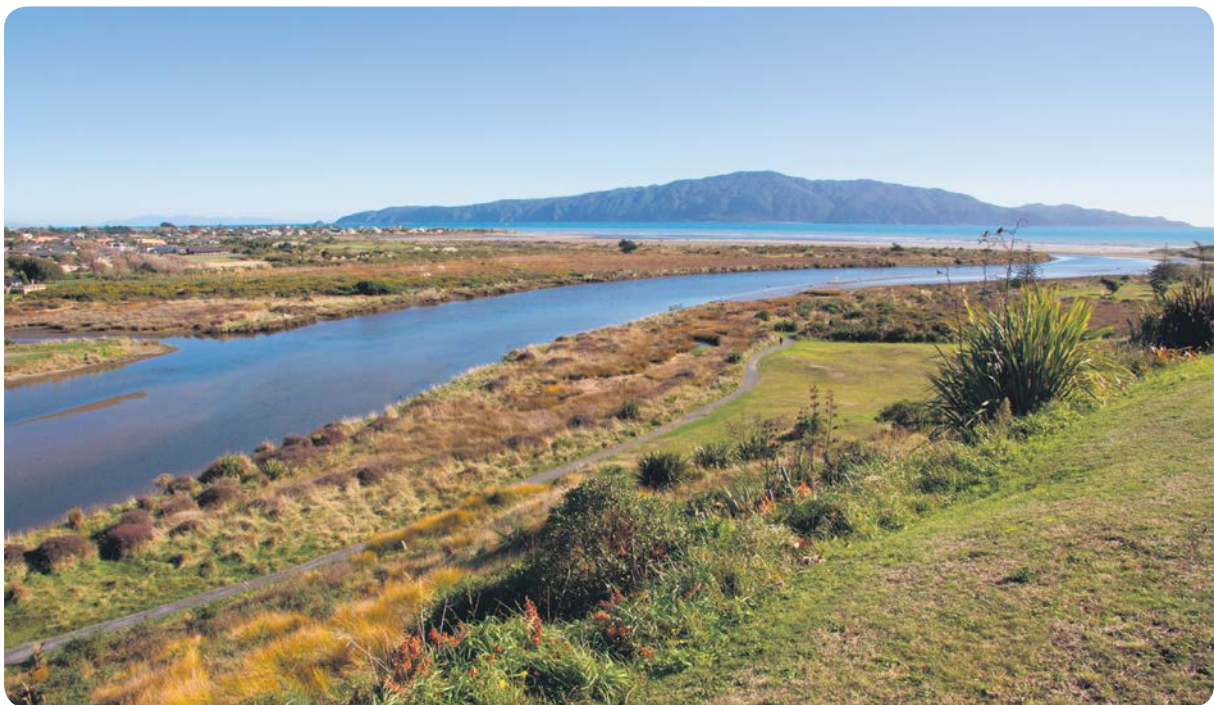
High rates of sedimentation continue to be the main issue for Waikanae Estuary

Indicator	2013/14 sedimentation rate (mm)	Mean sedimentation rate (mm/yr)	RPD (cm)	Low density macroalgal cover (Macroalgae Coefficient)	High density macroalgal cover (% of estuary)
Result	19.0	26.4	1.5	0.1	<1%

Monitoring results from Waikanae Estuary. Good results are shaded in green, fair results are shaded orange and poor results are shaded red.

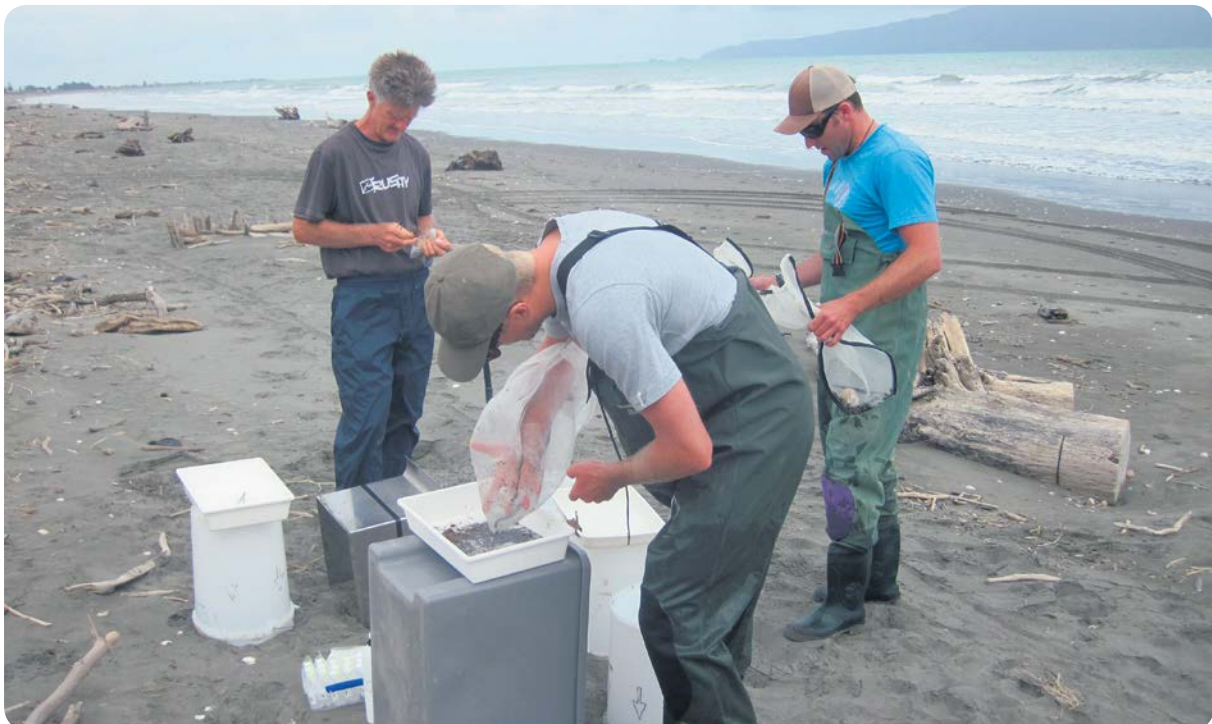
Scientists from Wriggle Coastal Management undertake monitoring at Peka Peka Beach

Indicator	RPD (cm)	Mud content (%)	Macroinvertebrate enrichment index
Result	>15	0.3-1.1	1.2-3.3

Monitoring results from Peka Peka Beach which is in excellent condition

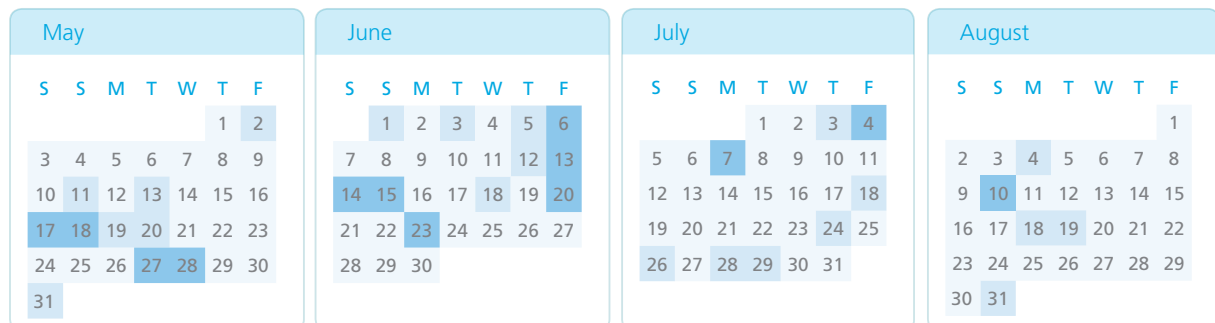
In winter 2014 there were 13 exceedances of the national standard for PM10 at the monitoring site in east Masterton

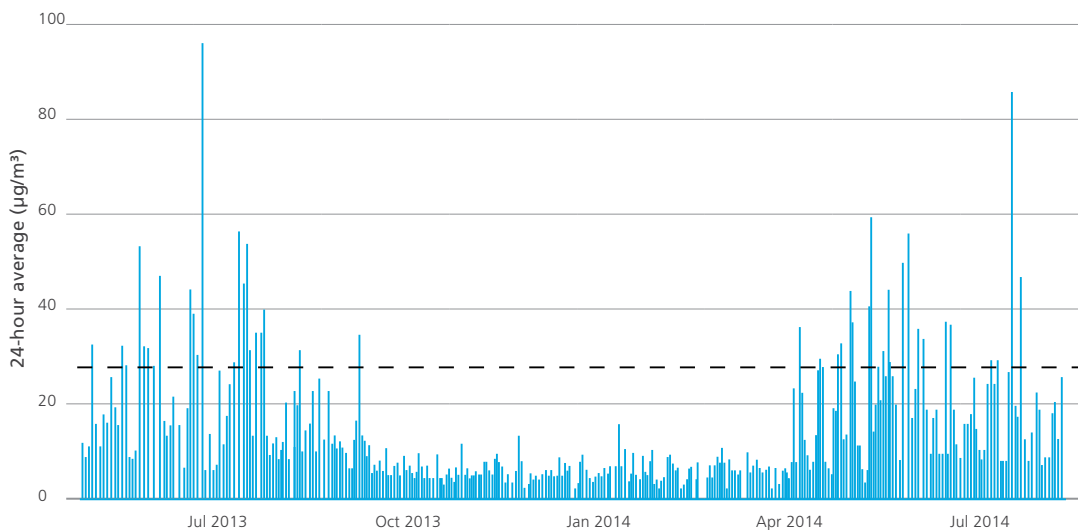
During winter 2014 there were 31 days where PM2.5 failed to meet the World Health Guideline limit¹⁴ (shown by the dashed line) at the monitoring site in west Masterton

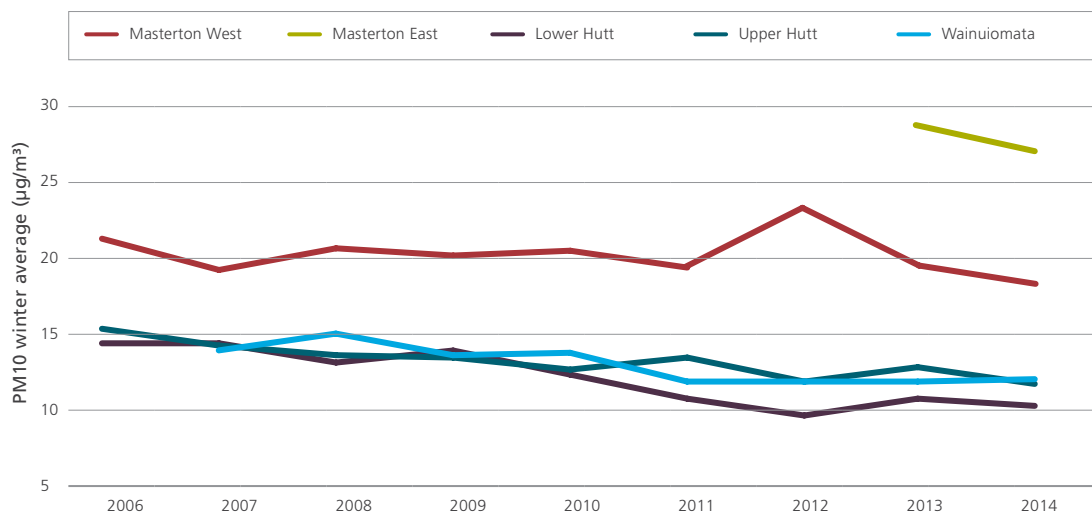
Levels of PM10 in Masterton during winter 2014 were the lowest on record

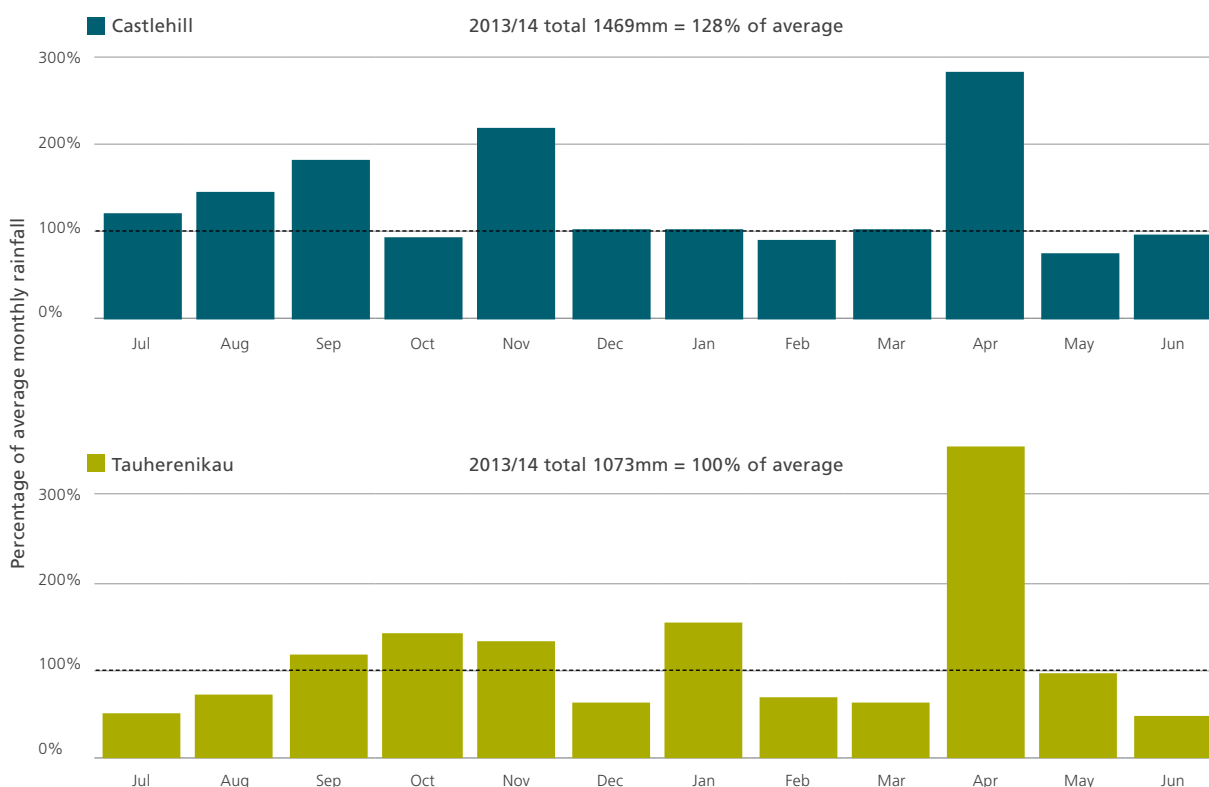
Although the 2013/14 year was generally wetter than normal seasonal totals varied with winter and summer generally producing lower than normal rainfall, while spring and autumn brought rainfall well in excess of average

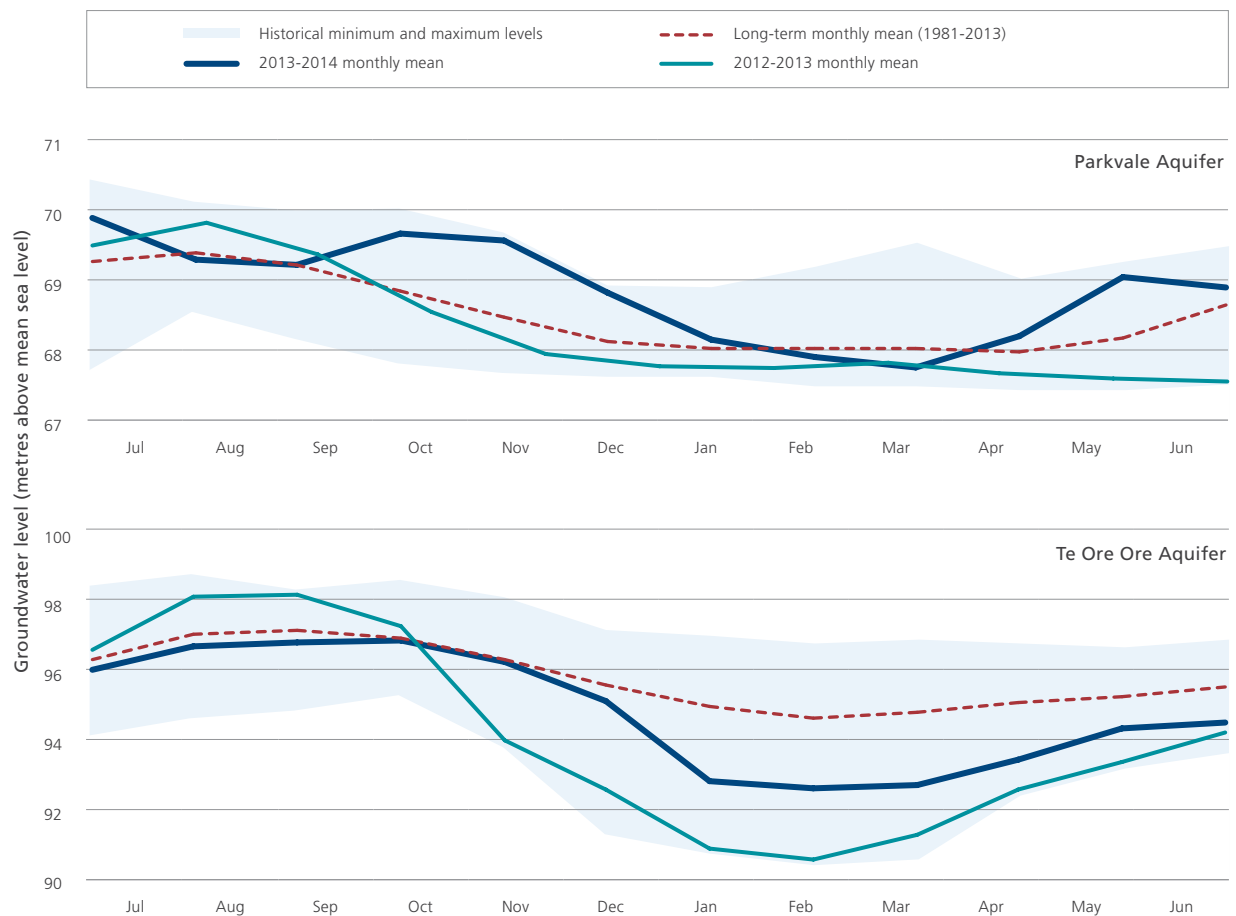
Groundwater levels in the Parkvale Aquifer were largely above average, whereas levels in the Te Ore Ore Aquifer were below average during summer and autumn although not to the extent of the previous year

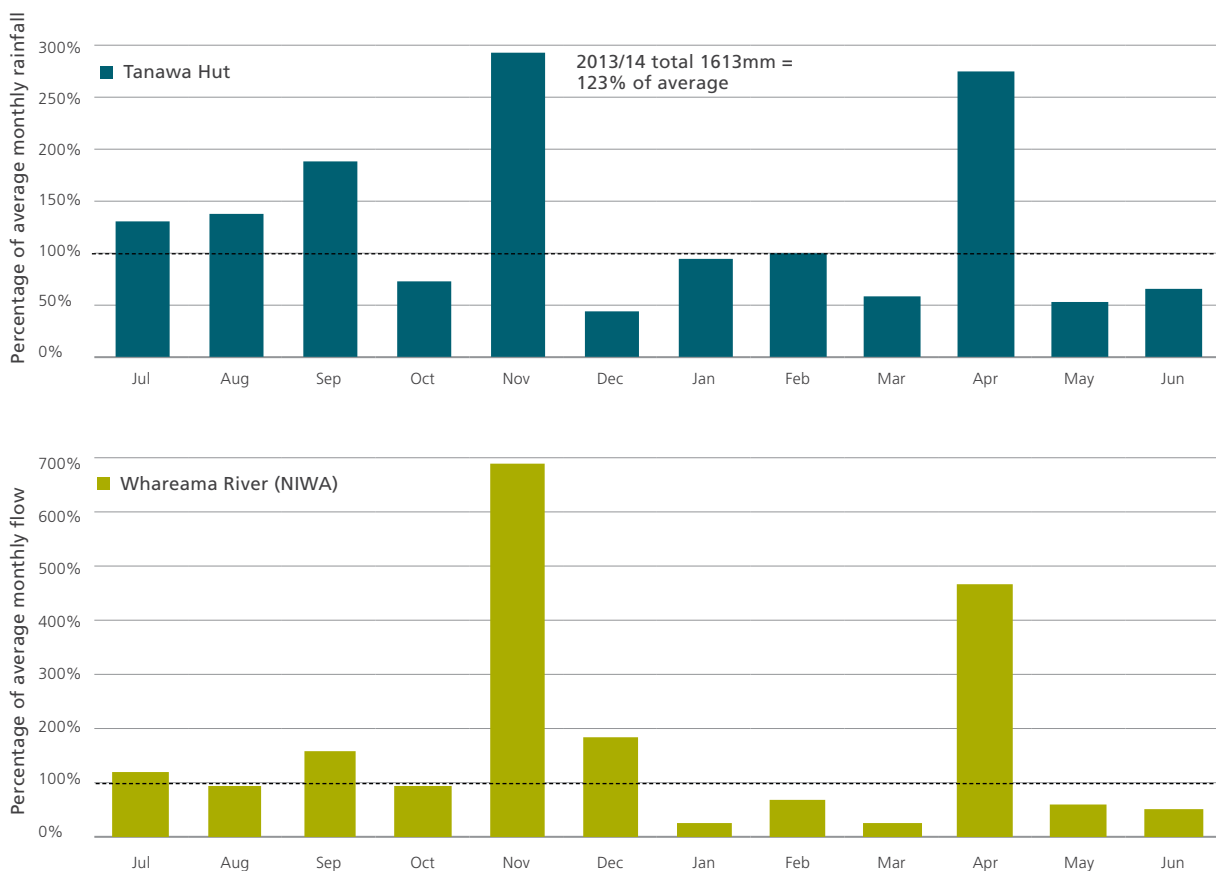
High flows in the Whareama River during November and April corresponds with exceptionally high rainfall over the same period

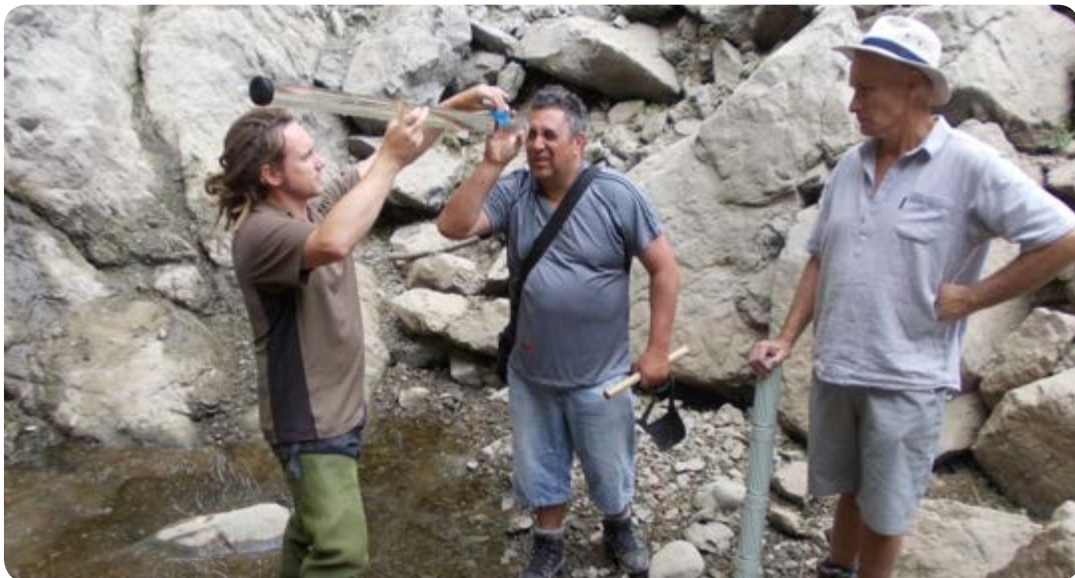
Monitoring Officer Brett Cockeram (left) shows PJ Devonshire and Mike Grace (Senior Policy Advisor Tangata Whenua, GWRC) a simple method for measuring the clarity of water
Photo courtesy of Hayley Vujcich, GWRC

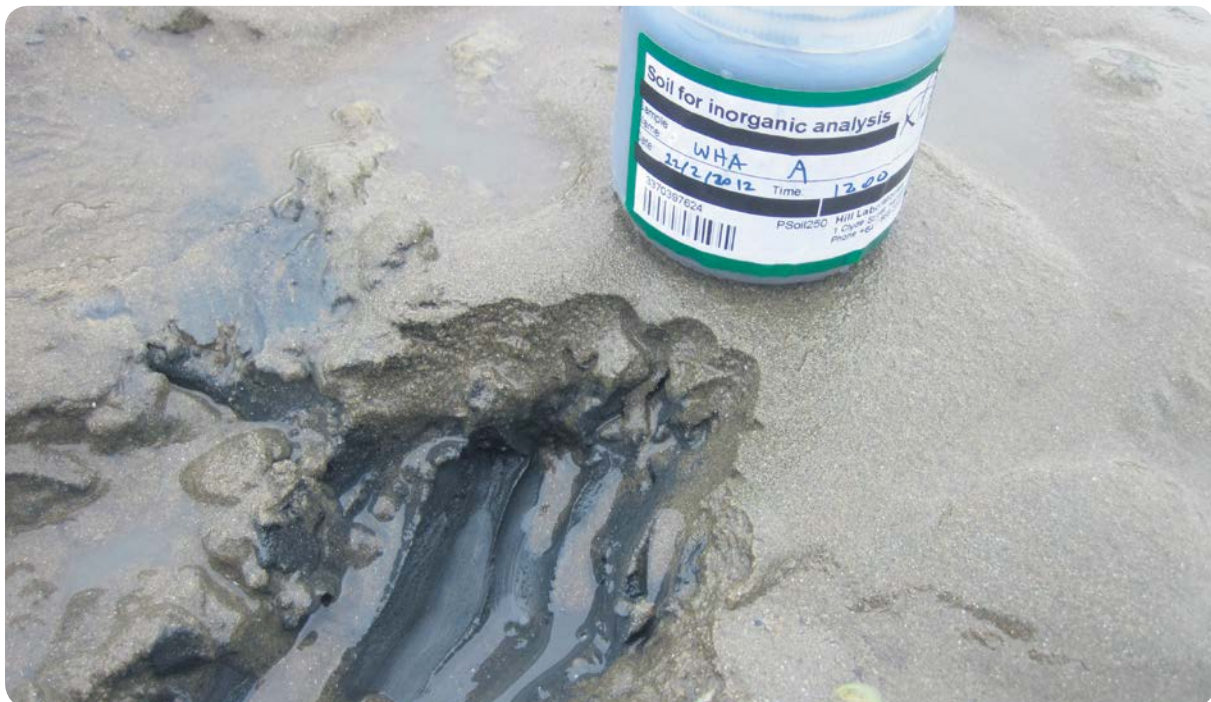
Excessive build-up of fine muds in Whareama Estuary is resulting in sediments that are low in oxygen and high in toxic sulphides

Indicator	Sedimentation rate 2013/14 (mm)	Mean sedimentation rate (mm/yr)	RPD (cm)
Result	20.0	11.2	1.0

Monitoring results from Whareama Estuary. Poor results are shaded in red and fair results are shaded orange.
